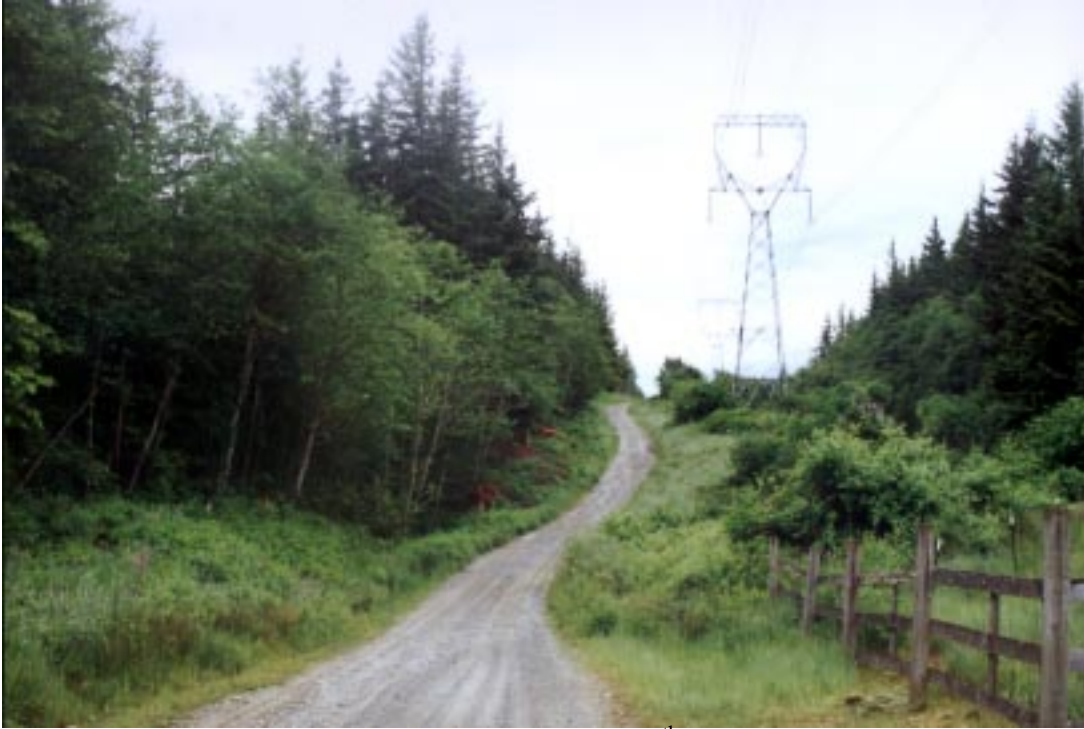
### Photo Pair 1

**Existing Setting** View looking north along SE 356<sup>th</sup> Avenue, north of Photo Pair 2.

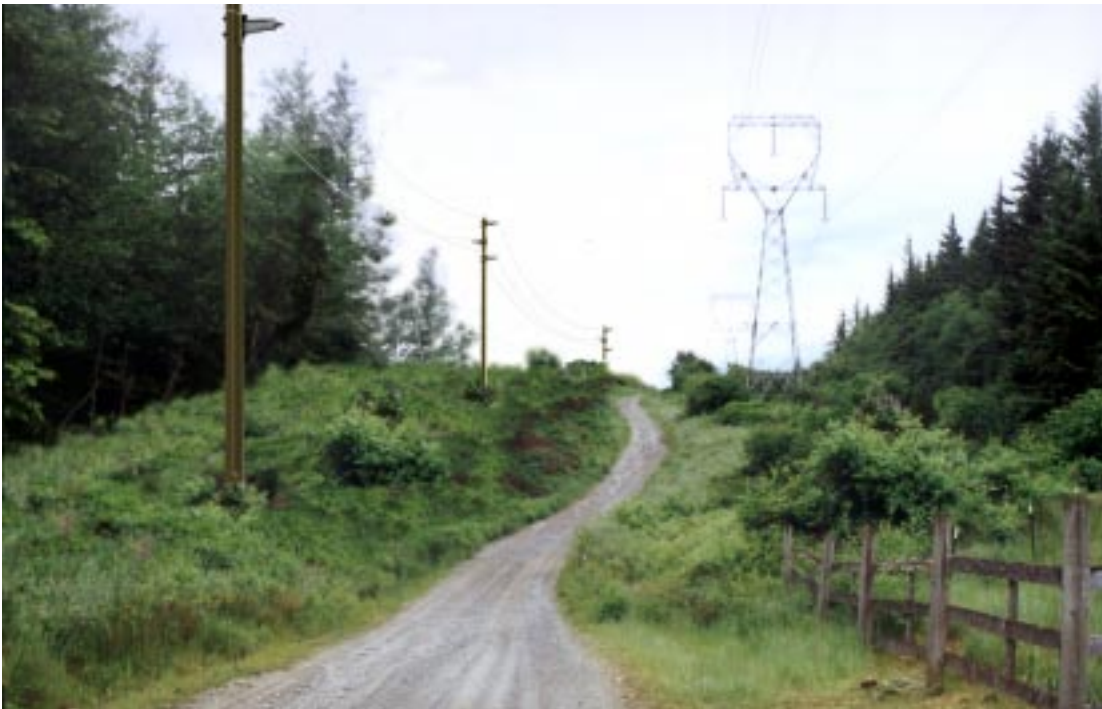
**Photo Simulation** View illustrates visual effect of the proposed wood pole line adjacent to the existing BPA transmission line.

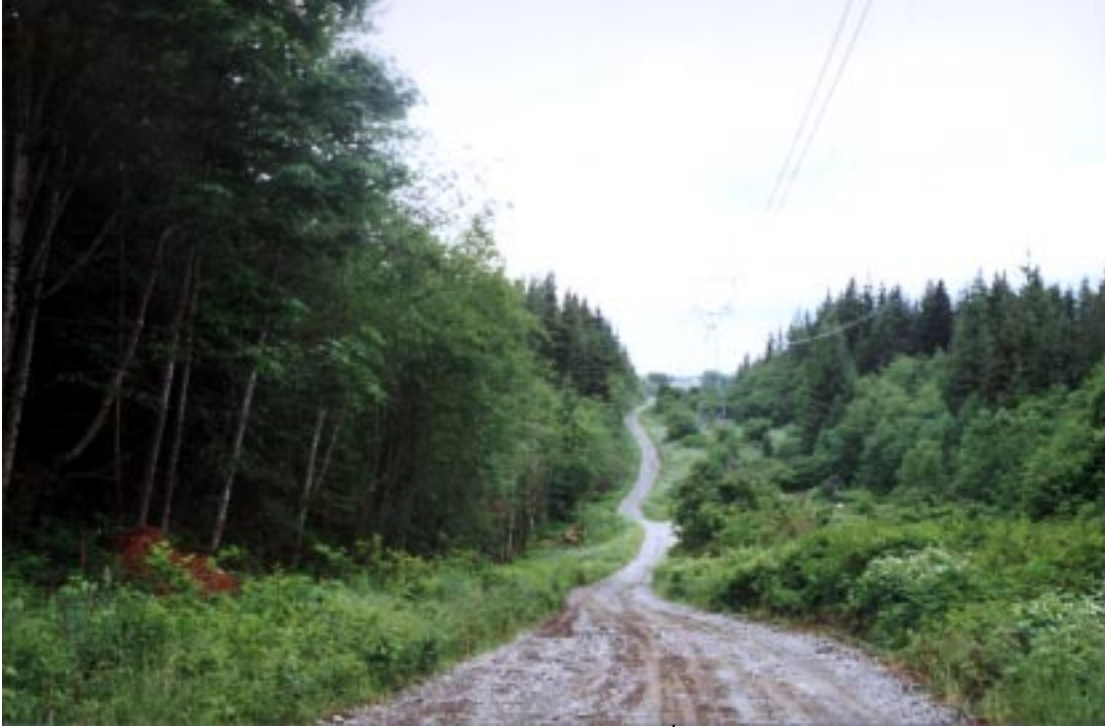
## **Photo Pair 2**

**Existing Setting** View looking north along SE 356<sup>th</sup> Avenue, south of Photo Pair 1

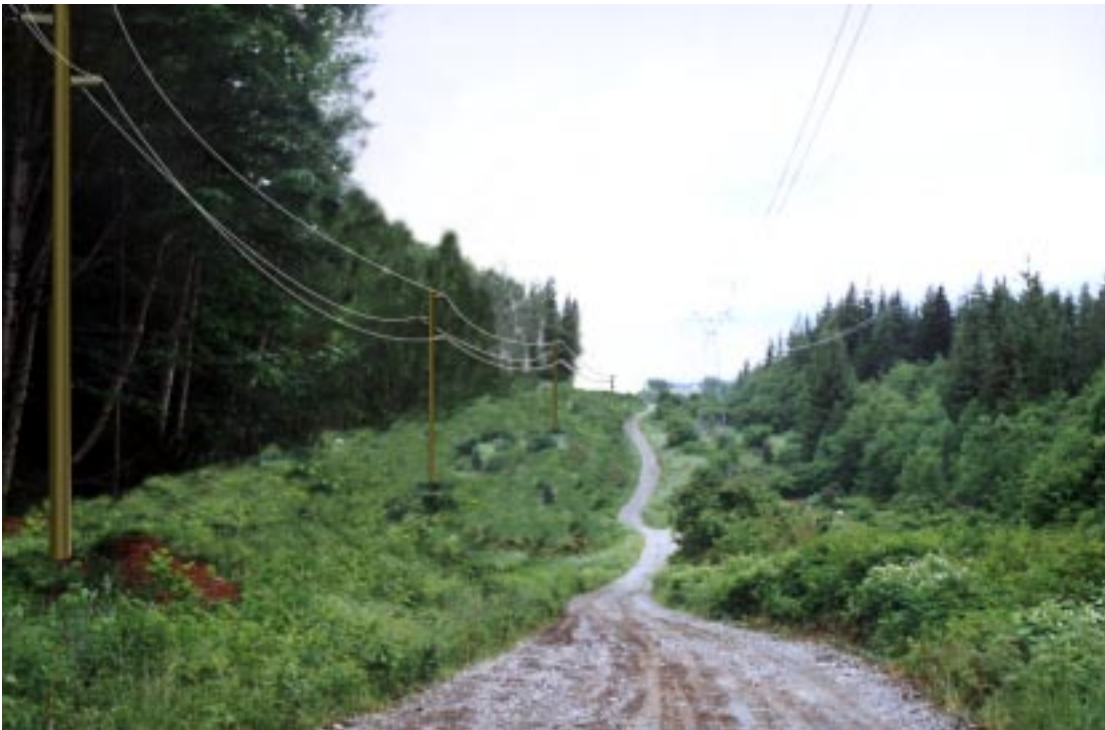
**Photo Simulation** View illustrates visual effect of proposed wood pole line adjacent to existing BPA transmission line, looking north along SE 356<sup>th</sup> Avenue.

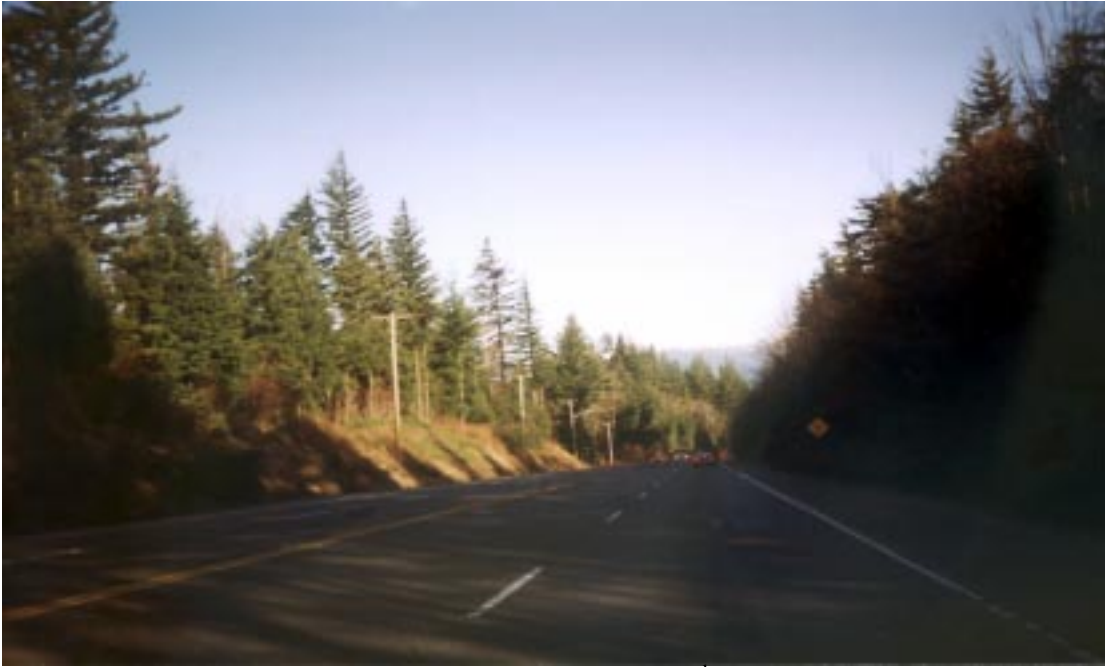
### Photo Pair 3

**Existing Setting** View looking west towards SE 372<sup>nd</sup> Avenue from the eastbound lanes of North Bend Way.

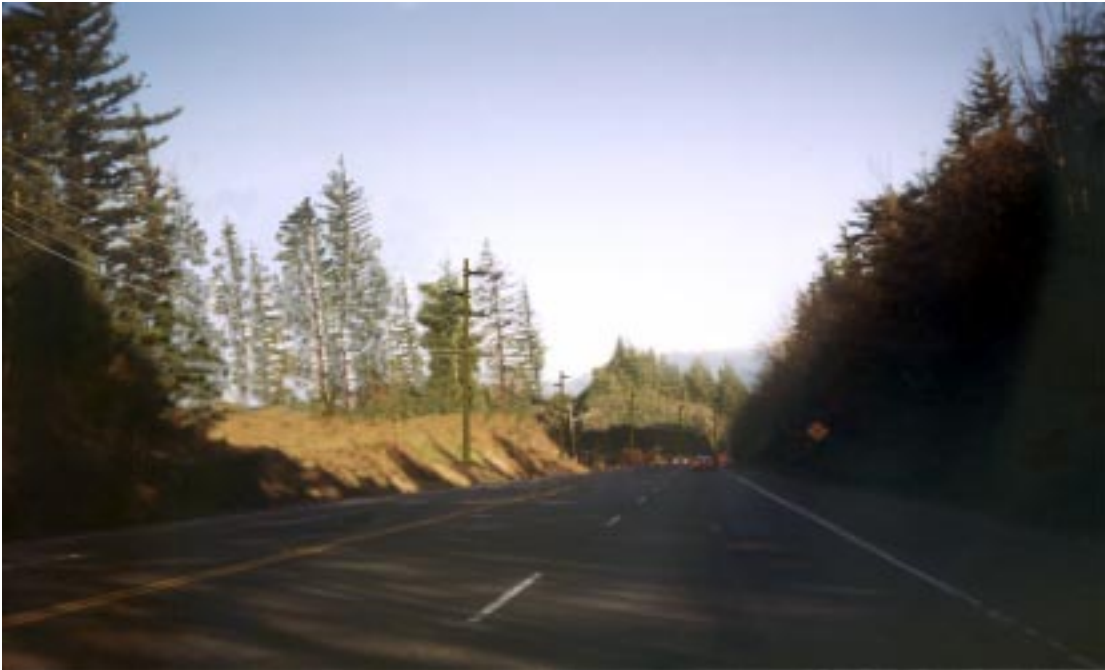
**Photo Simulation** View illustrates visual effect of BPA transmission line and Puget underbuild on BPA poles. Major effect would be the amount of clearing that would be necessary in this area to construct, operate and maintain the transmission line.

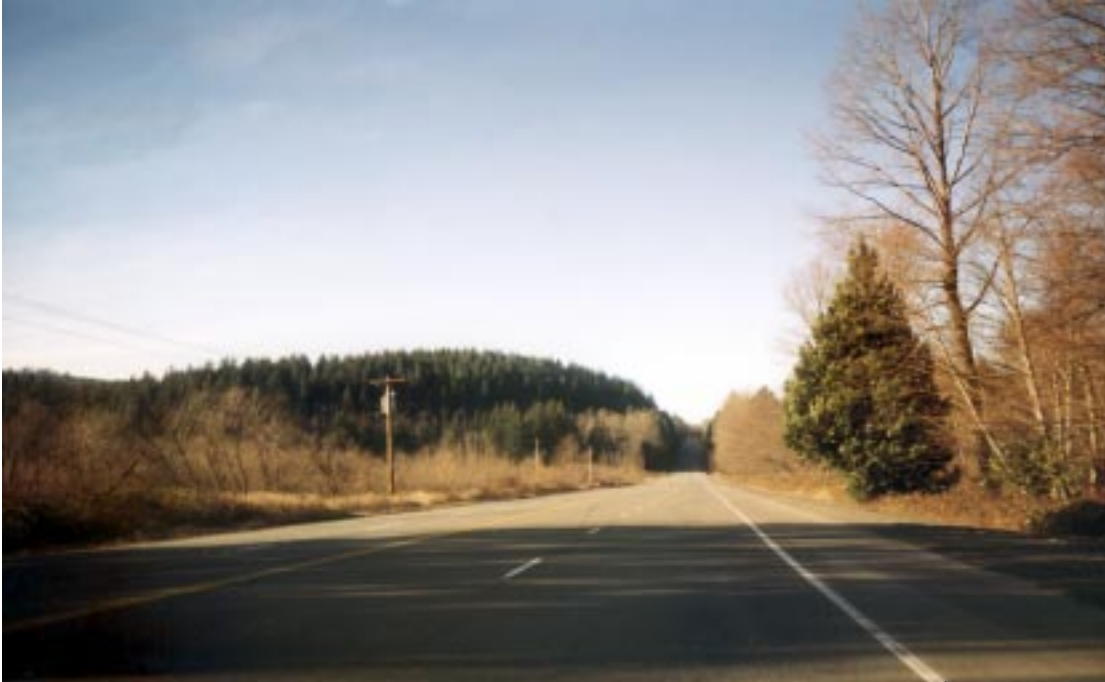
**Photo Pair 4**

**Existing Setting** View looking west from North Bend Way near SE 394<sup>th</sup> Place, just west of the Snoqualmie Valley Railroad right-of-way.

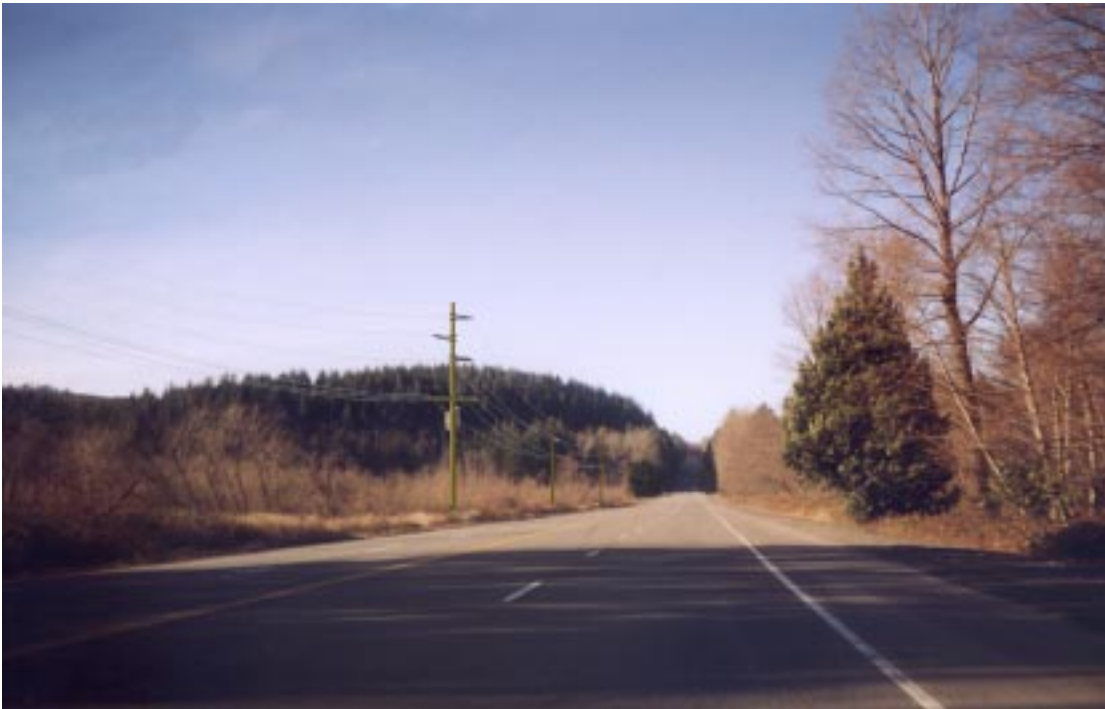
**Photo Simulation** View illustrates visual effect of BPA transmission line and Puget underbuild. Little clearing would be necessary in this portion of North Bend Way.

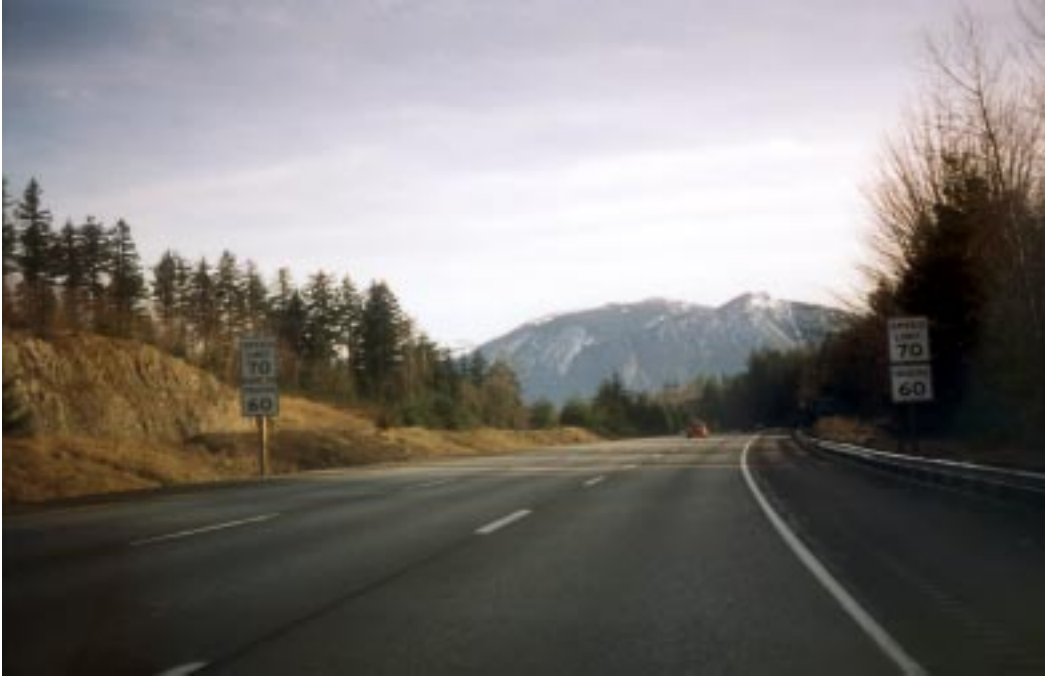
### Photo Pair 5

**Existing Setting** View looking east from eastbound lanes of I-90. Mt Si dominates view and motorists' attention.

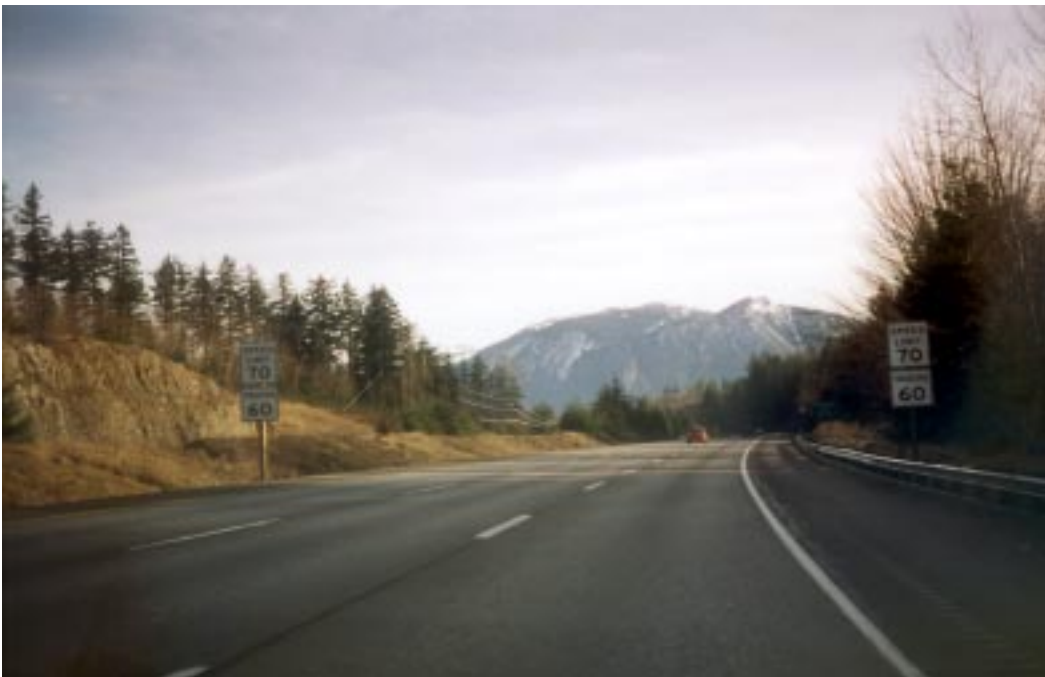
**Photo Simulation** View illustrates visual effect of BPA transmission line just coming into view for eastbound motorists as they pass rock bluff on north side of I-90. Although the transmission line would be noticeable to motorists, Mt. Si still dominates view.

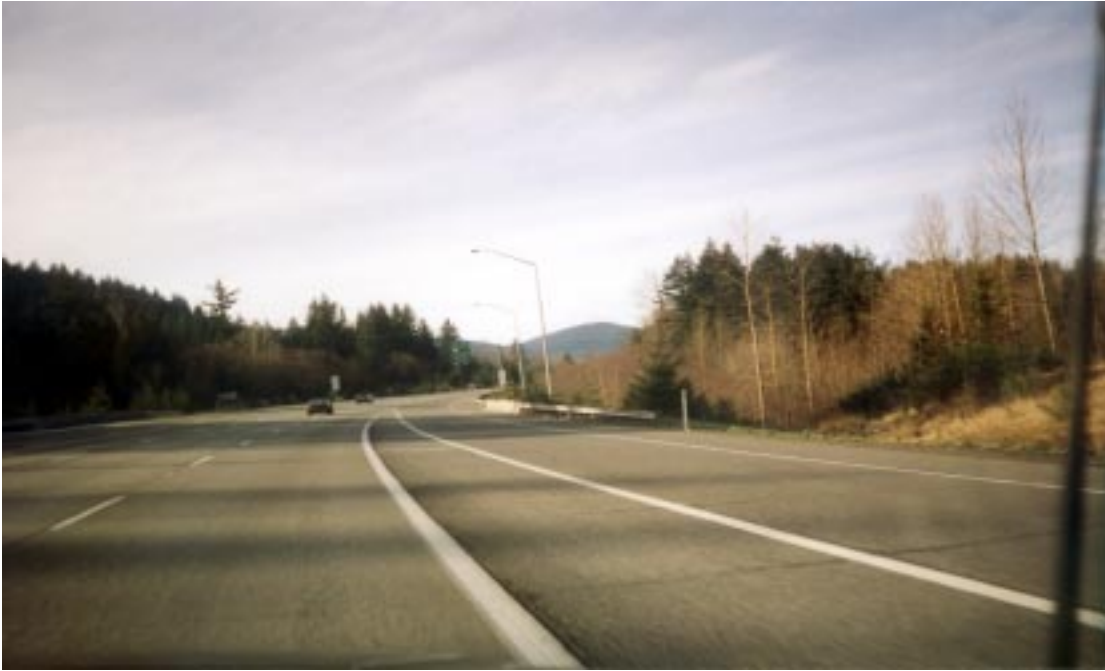
**Photo Pair 6**

**Existing Setting** View looking west from westbound lanes of I-90 near North Bend Way on ramp.

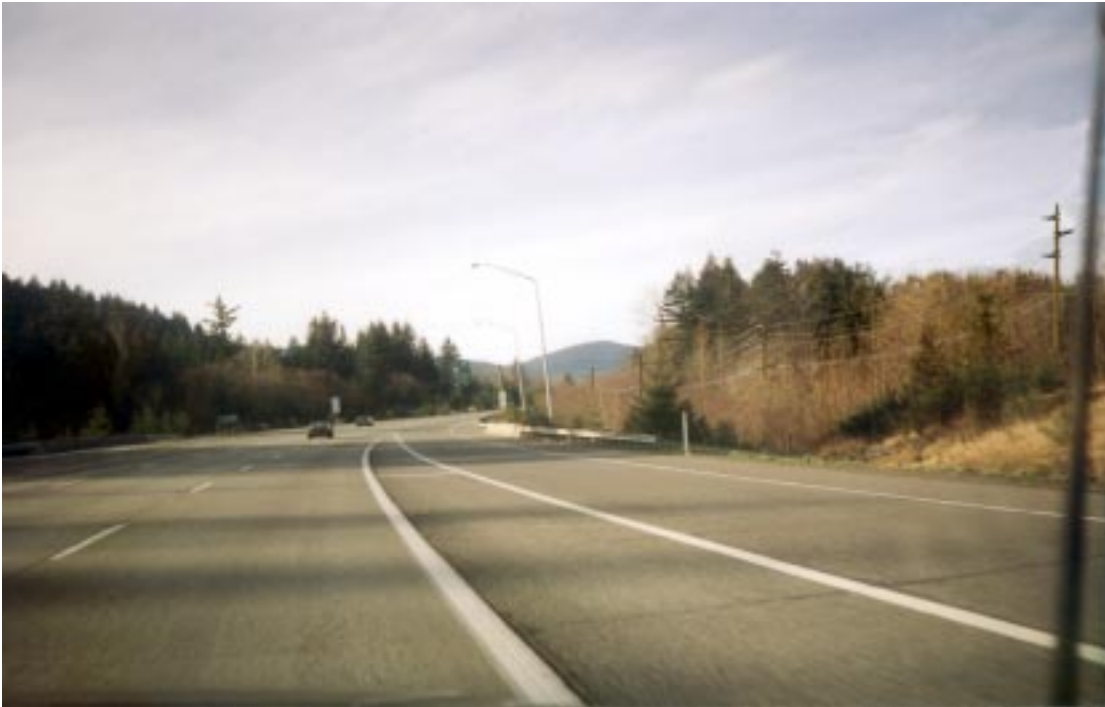
**Photo Simulation** View illustrates visual effect of transmission line in I-90 right-of-way. Portions of transmission line would be noticeable to motorists in this area.
